# Manhole Inspection Summary

Manhole # S53I\_\_009MH

Insp Date: **2/27/09 12:01 PM**

**Location** Address: **3129 eastern av**

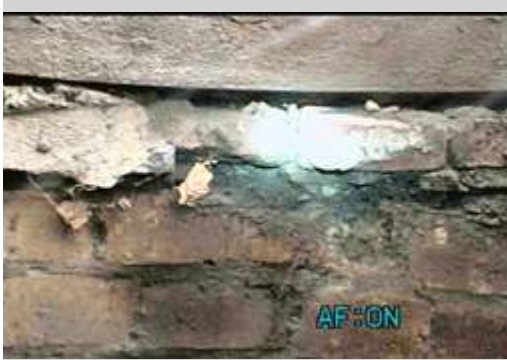
Defect 4

Condition: ☐ Sound ☐ Cracked ☐ Root Intrusion ☒ **Loose Brick** ☒ **Deteriorated**

Loose bricks chimney deteriorated

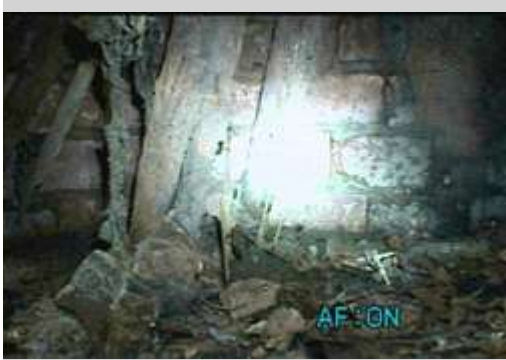
Defect 3

Condition: ☐ Sound ☐ Cracked ☐ Root Intrusion ☐ Deteriorated ☐ Leaks ☒ **Debris**

bench debris

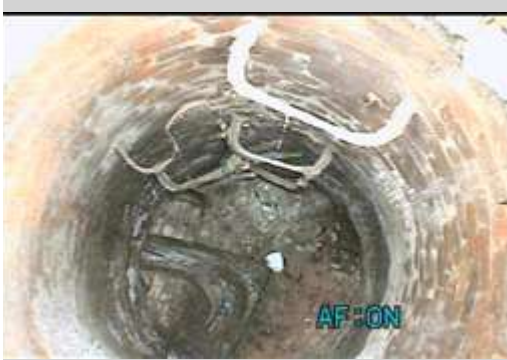
Defect 2

**Steps** Count: **6** Missing: **1** ☒ **Corroded**

corr steps

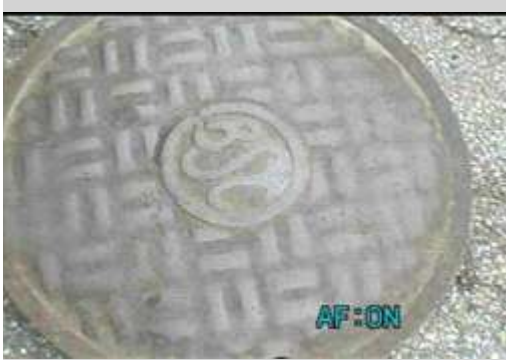
Defect 1

Type: **Sanitary** Condition: **Worn** Cover Material: **Cast Iron**

worn cover
